VARG P&A

Repsol Norge AS

Varg Field

PL 038

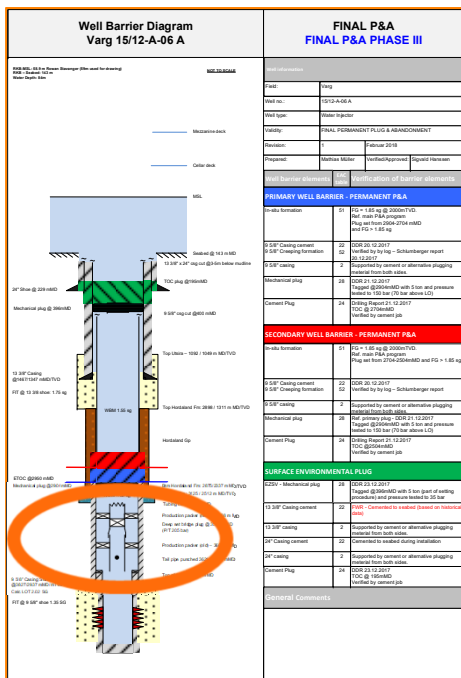
Operations Sequence Phase I

Well status prior to Rig arrival

- Tubing bull headed to seawater,
- A-annulus bled off and topped up with seawater.
- Deep set mechanical plug installed in the tailpipe.

Phase I P&A

- Punch and cut the tubing.
- Punch and release ASV (if installed).
- Set and test shallow pump open tubing plug.
- Nipple Down XMT.

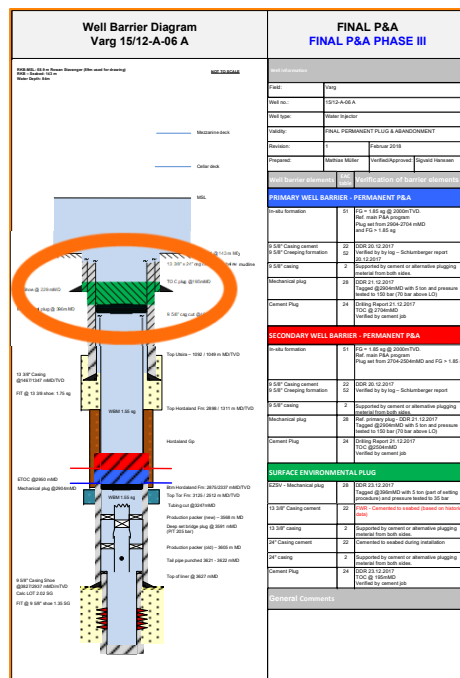
Operations Sequence Phase III

Phase III P&A

- Cut 13 3/8" casing and 24" conductor approximately 3m below seabed.
- Retrieve Wellhead, 13 3/8" casing and 24" conductor.

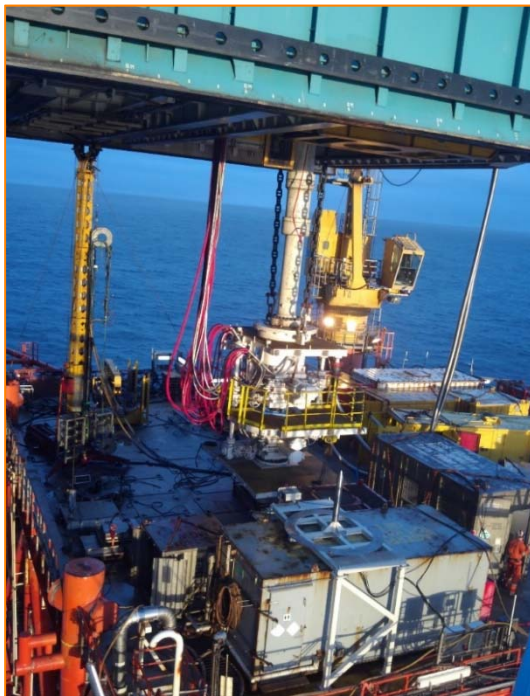
Situation at Varg with RollSafe deck installed

working with both phase I & phase II

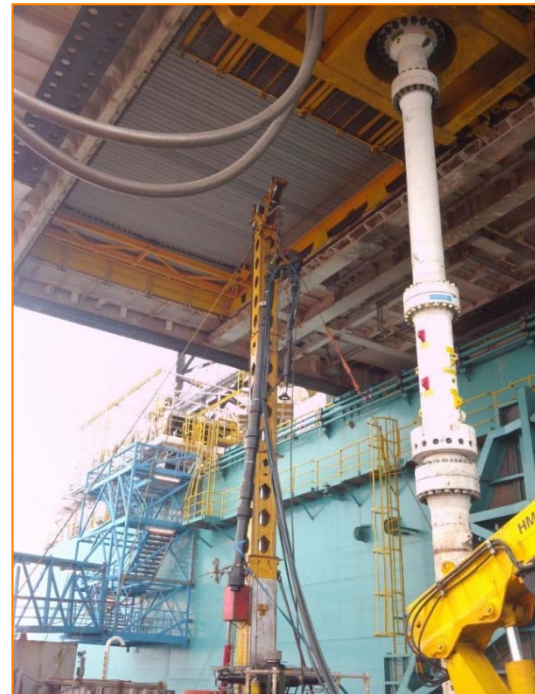
BOP on Varg main deck

BOP in moonpool on RS and RollSafe deck installed
